Pro-Inspector, Inc

1843 Water St
St. Paul, MN

Prepared for: Jane Smith

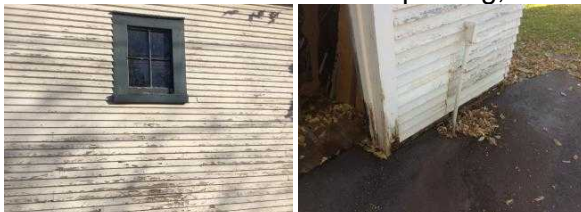
Exterior Surface: Wood. Paint peeling, Rot noted

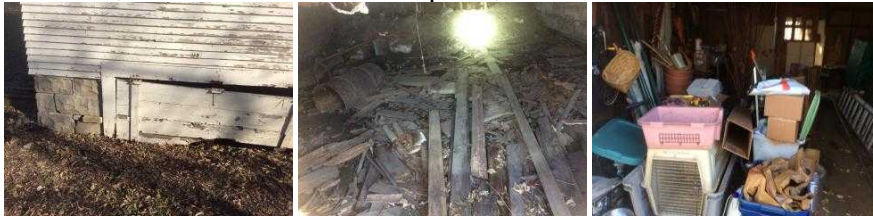
Floor/Foundation: Does not appear to be able to support a car, A contractor is recommended to evaluate, Debris noted in crawl space, Personal items - Limits view

1. Rear Garage Floor/Foundation: Does not appear to be able to support a car, A contractor is recommended to evaluate, Debris noted in crawl space, Personal items - Limits view

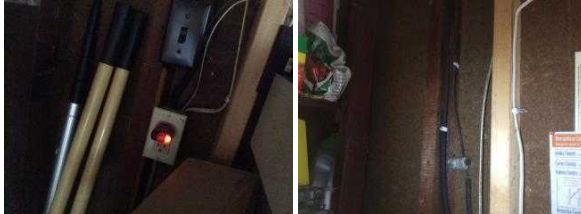
Potential Hazard Electrical: Improperly wired, Knob and tube wiring, Suggest evaluation by licensed electrician

1. Rear Garage Electrical: Improperly wired, Knob and tube wiring, Suggest evaluation by licensed electrician

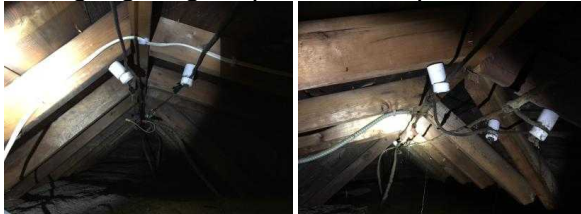
Acceptable	Unable to Inspect:
Acceptable	Roof Framing:
Acceptable	Sheathing:
Acceptable	Ventilation:
Marginal	Insulation: Blown in, Cellulose. Hatch not sealed/weather stripped
Acceptable	Insulation Depth: 12"
Potential Hazard Wiring/Lighting: Exposed wire splices, Knob add tube wiring

7. Peak Attic Wiring/Lighting: Exposed wire splices, Knob add tube wiring
