Pro-Inspector, Inc.

3636 Noble Ave N
Robbinsdale , MN

Prepared for: Laura Bettelyoun

Prepared by: Pro-Inspector, Inc.
4207 Upton Ave S
Minneapolis , MN 55410

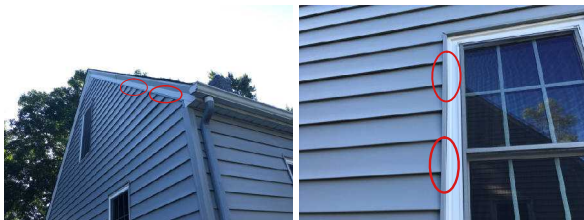
- 1. Marginal Type: Vinyl siding. Caulk has dried out and needs to re-caulked at Chang of surface facia & window trim

3. Entire House Exterior Surface Type: Vinyl siding. Caulk has dried out and needs to re-caulked at Chang of surface facia & window trim
4. Trim: Loose

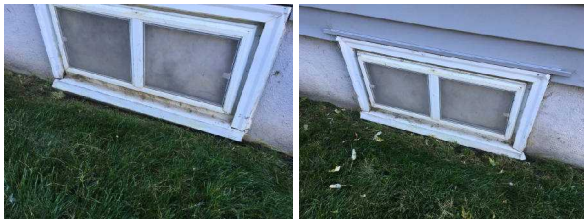
- 2. Acceptable Foundation: Concrete block.
- 3. Marginal Trim: Loose

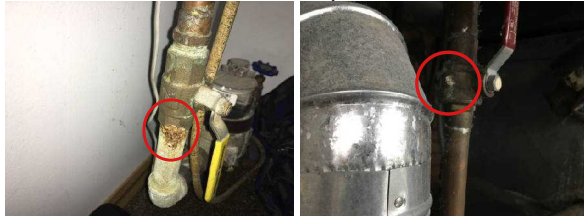
Service Line: Copper
Main Water Shutoff: Basement/Front of house.
Water Lines: Copper., PEX. Corrosion on water line joint from possible earlier leak, Corrosion on water line valve from possible earlier leak, Note: Uncapped valves/drain hoses - Two

11. Water Lines: Copper., PEX. Corrosion on water line joint from possible earlier leak, Corrosion on water line valve from possible earlier leak, Note: Uncapped valves/drain hoses - Two
12. Drain Pipes: Cast iron., Galvanized., PVC. Non-stainless steel connections - Two
13. Water Softner: Operating system is not part of home Inspection. Needs salt, Note: Might consider having a soft water contractor tune-up and adjust system to your size household

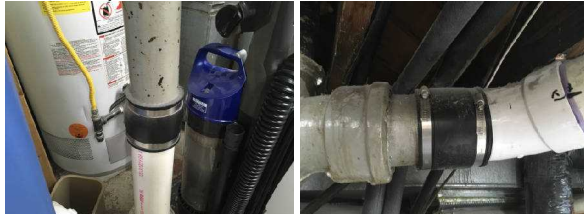
Drain Pipes: Cast iron., Galvanized., PVC. Non-stainless steel connections - Two

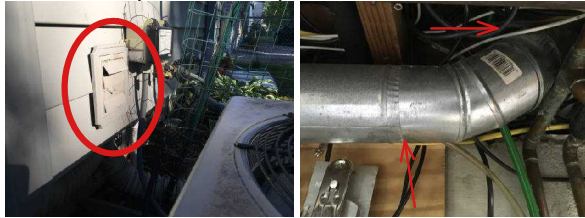
| 13. Marginal | Dryer Vent: Rigid metal. Needs cleaning - Outside vent - Check main line, Connections made without tape - Foil tape is recommended |

18. Basement: Laundry Room/Area Dryer Vent: Rigid metal. Needs cleaning - Outside vent - Check main line, Connections made without tape - Foil tape is recommended
